**ST JEROME'S CHURCH,  
LLANGWM, PEMBORKESHIRE:  
ARCHAEOLOGICAL WATCHING  
BRIEF  
(SM 99030 09380)**

**HERITAGE LLANGWM PROJECT**

Prepared by DAT Archaeological Services  
For: Heritage Llangwm

RHIF YR ADRODDIAD / REPORT NO. 2016/12

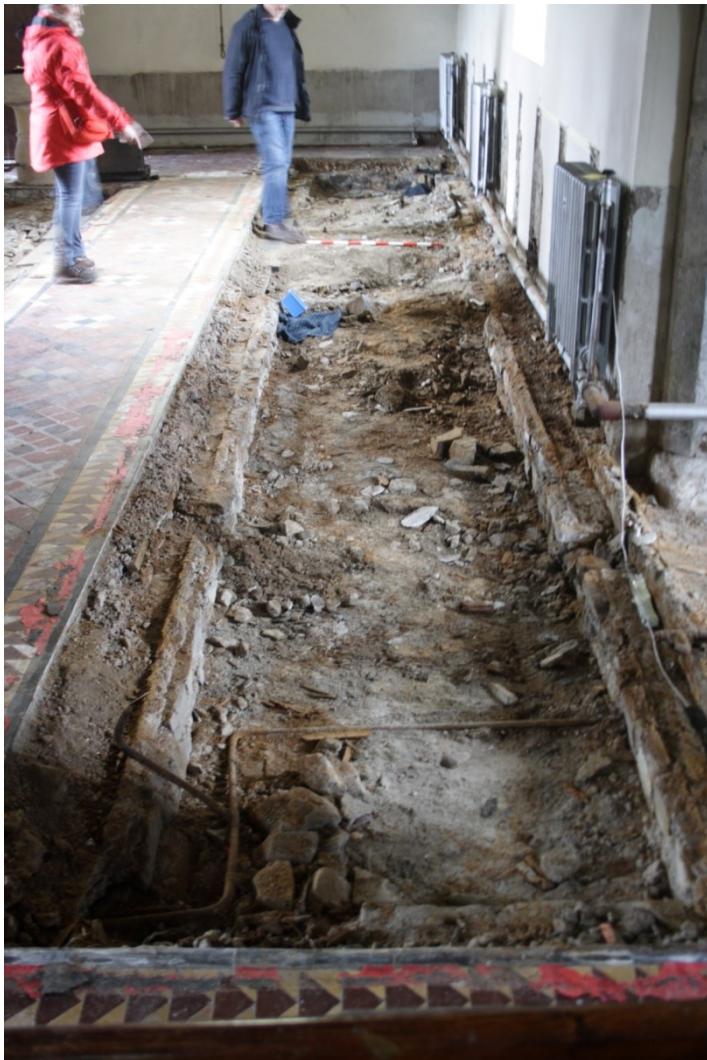
**Photo 4:** The northern side of the nave following removal of the suspended timber floors, 1m scale

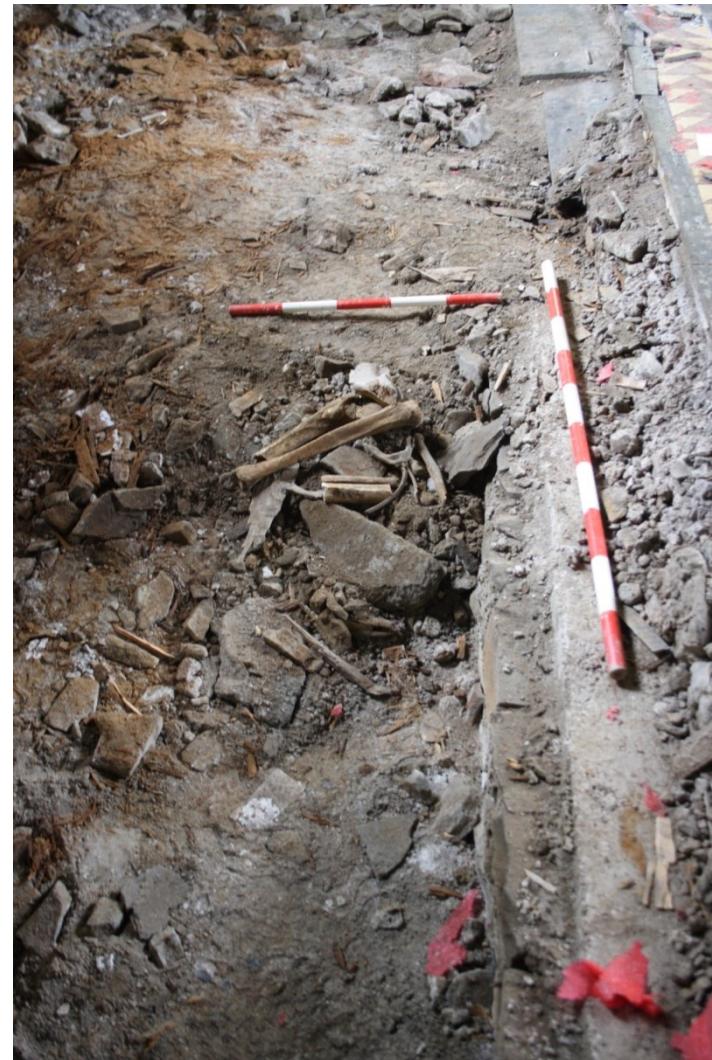
5.1.3 Photo 5 shows a small sample of the human bone found on the surface. The human remains had been previously disturbed and did not represent in-situ burials. It is most likely that they represent burials within the nave that were disturbed and mixed up during excavation and backfilling when the Victorian floor was created. Burials are frequently found inside the naves of churches and it is common for them to have been disturbed by Victorian restoration works, especially where new floors were inserted into the church and supporting walls were constructed.

**Photo 5:** Example of some of the previously disturbed and disarticulated human remains found beneath the suspended timber floor of the nave, 0.5m and 1m scales

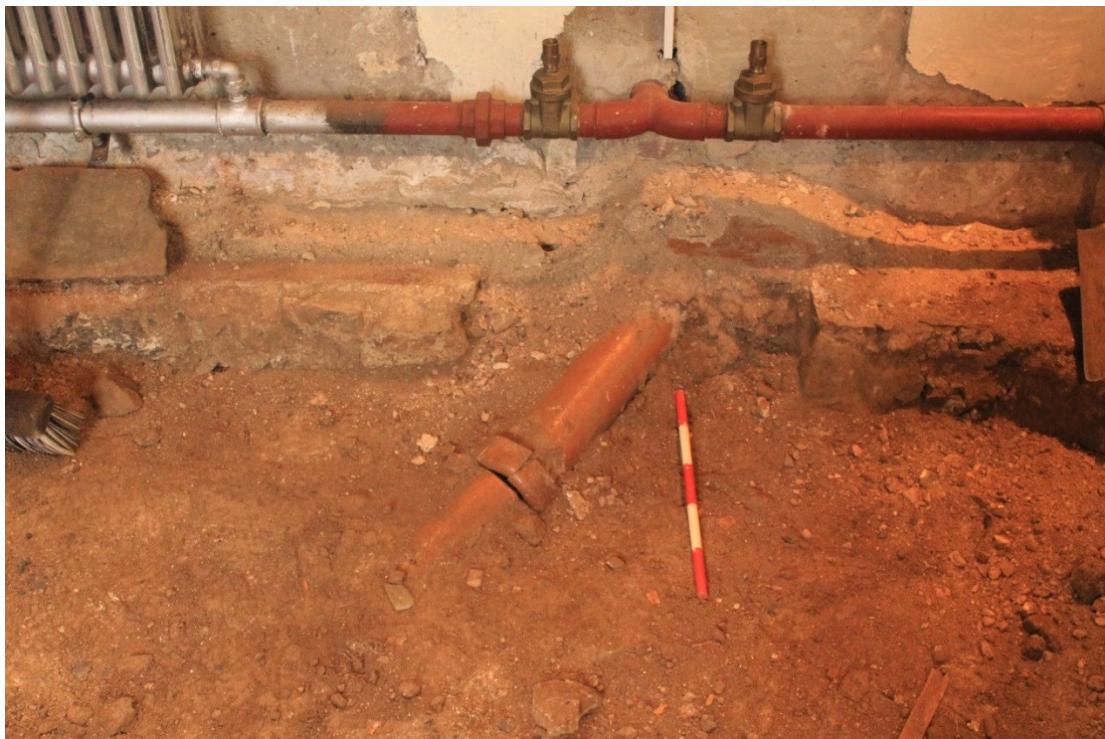
**Photo 8:** The ceramic pipe unearthed about halfway along the north wall of the nave, 0.5m scale

5.1.11 The previously discovered ceramic pipes running to the walls of the nave turned out to be tuyeres (air intakes) for the stove (Photo 16). The other two ceramic pipe sections that had been observed during machining proved to be parts of the horizontal chimney of the stove. Photo 17 shows a vertical view of the chimney where it left the square-sectioned metal chimney. Its top was damaged by machining and inside can be seen a quantity of soot and a partially burned fragment of newspaper that was recovered for further scrutiny. Photos 18 – 22 show the heating system and details of it after excavation. Photos 23 and 24 show the route of the chimney up from the floor to the roof of the church at the corner between the north transept and the chancel.

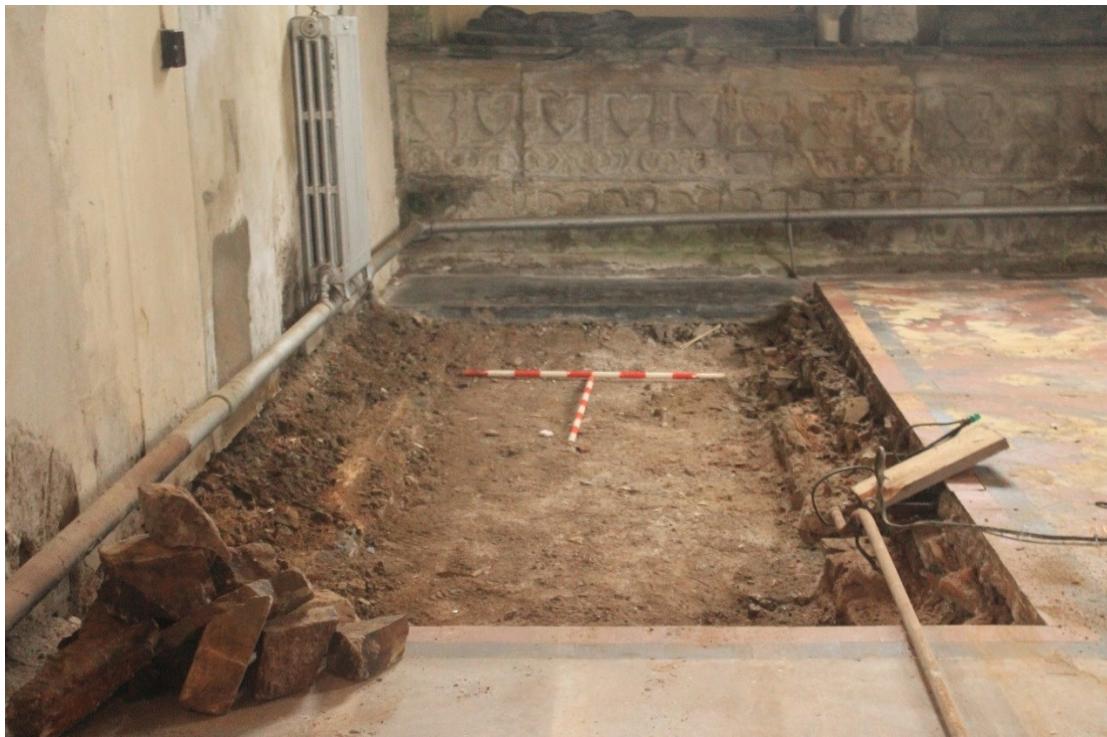
5.1.6 A similar process was undertaken on the western side of the north transept (Photo 9). Two slabs that appeared to be part of former headstones were also removed with the rubble, but neither had any markings upon them (Photo 10).

**Photo 9:** Western side of the north transept after hand excavation of most of the underfloor rubble deposit, 2 x 1m scales.

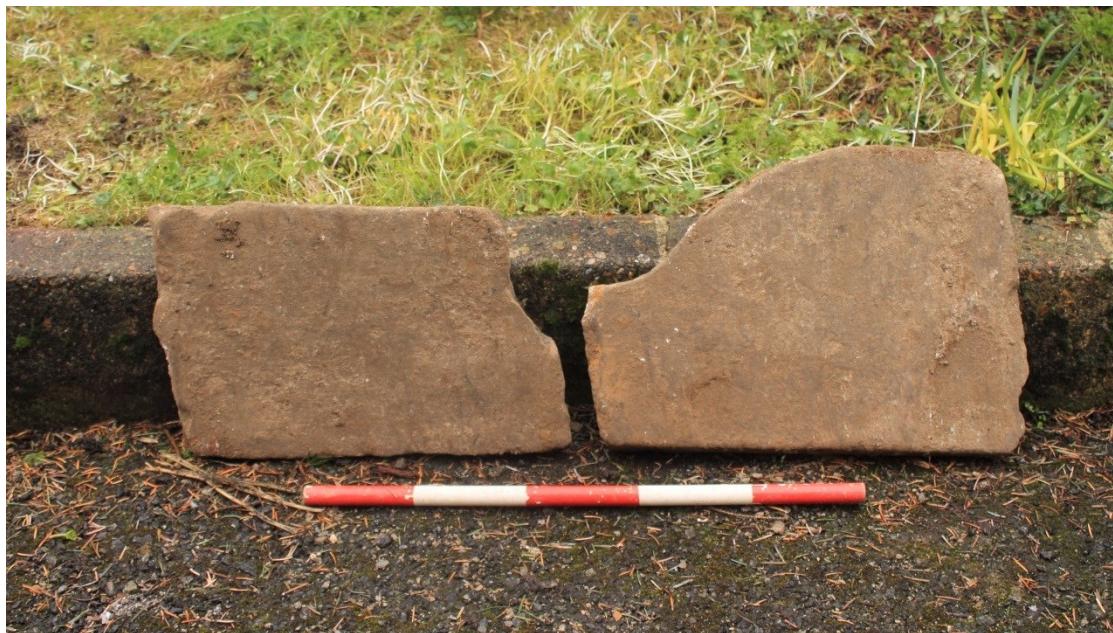
**Photo 10:** Two slabs found in the underfloor rubble that are thought to be the remains of headstones, 0.5m scale

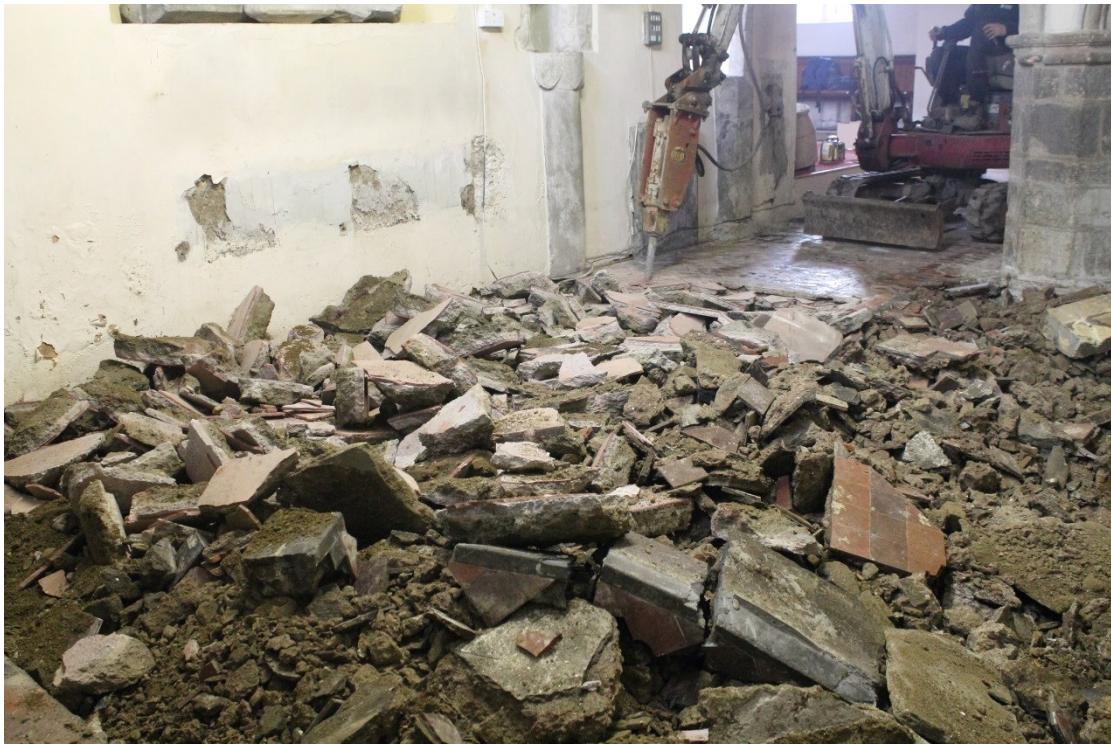
- 5.1.9 On the 7th of March, the concrete and tiled floor remaining in the north transept and the nave was broken up with a pneumatic drill (Photo 11). Further ceramic piping c.25cm in diameter was found in two locations: just below the concrete near to the squint on the corner between the north transept and the chancel (Photo 12) and under the concrete about halfway down the central aisle of the nave (Photo 13). Both sections were laid horizontally.

**Photo 11:** Breaking of the concrete and tile floor on the eastern side of the north transept

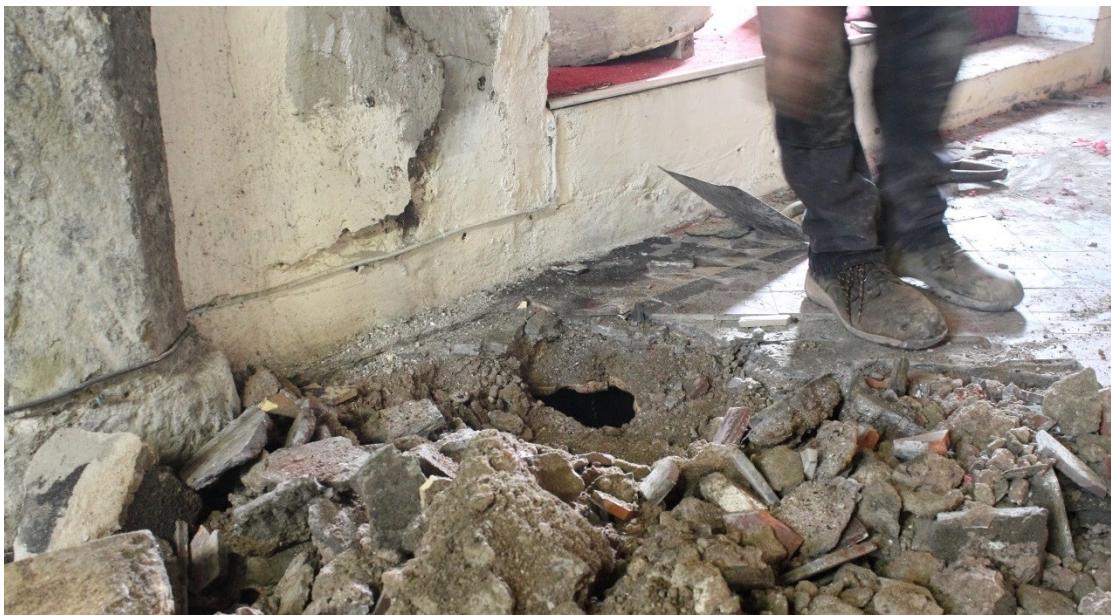
**Photo 12:** A small void shows where part of a ceramic pipe was partially drilled through on the corner between the north transept and the chancel

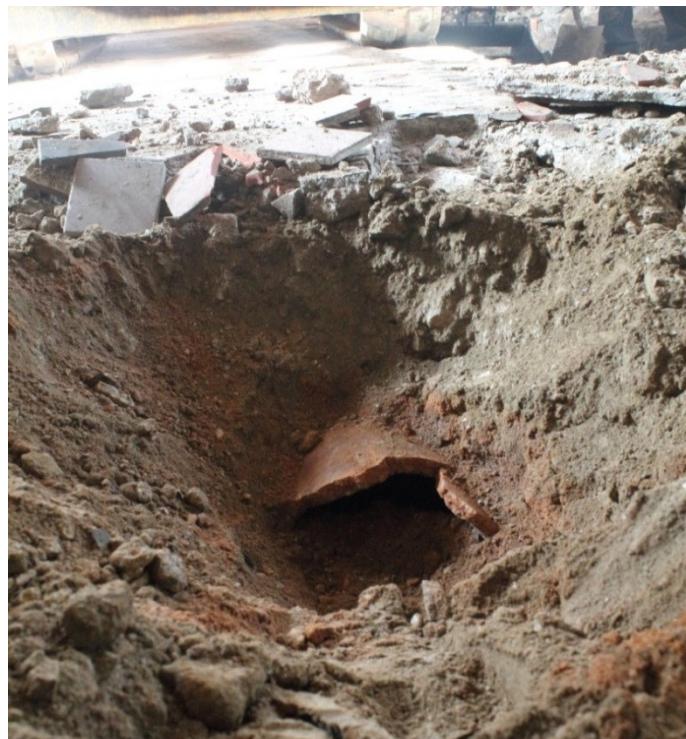
**Photo 13:** Part of a ceramic pipe was partially drilled through about halfway down the centre aisle of the nave

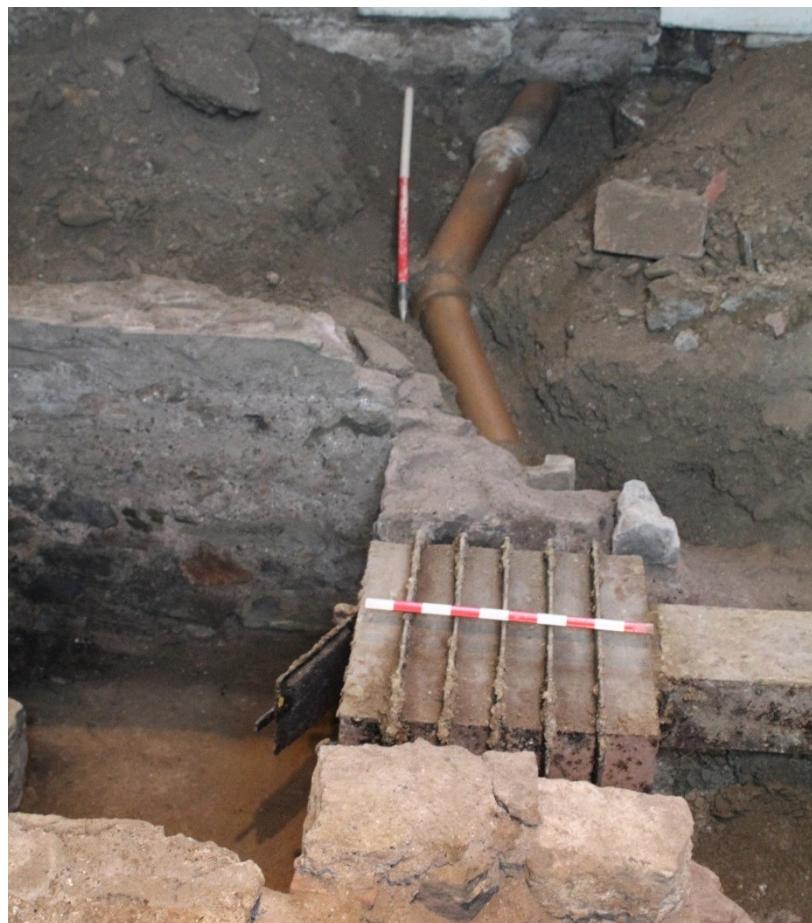
**Photo 16:** The stove pit and stove, with the northern tuyere coming from the northern wall of the nave and through the base of the small wall to the north of the stove, to provide air for the stove. The near scale is 0.5m long and the far one is 1m long.

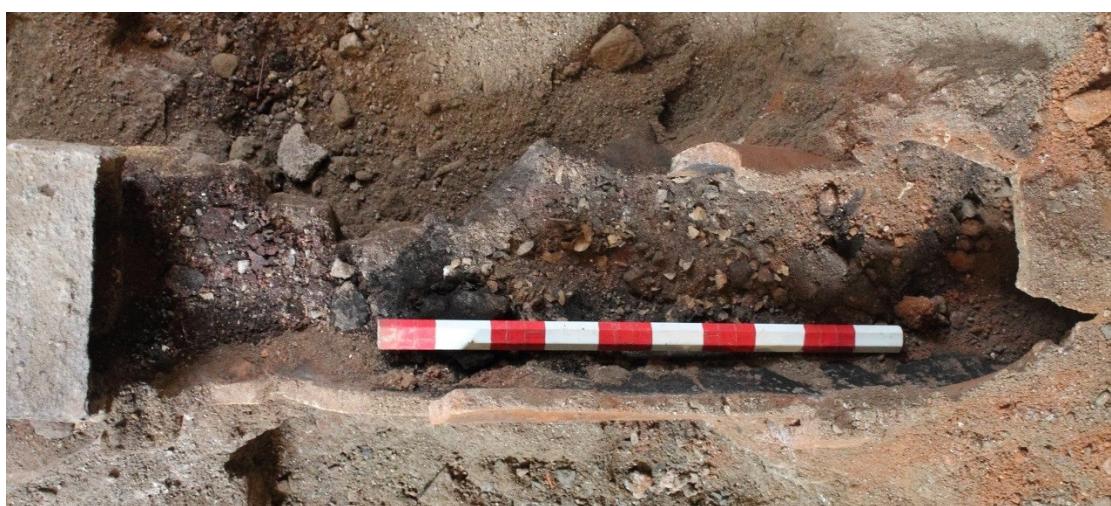
**Photo 17:** Plan view, facing north, of the section of ceramic chimney where it was joined to the metal chimney. Soot and a partially burned fragment of newspaper remain in the chimney, next to the 0.5m scale.

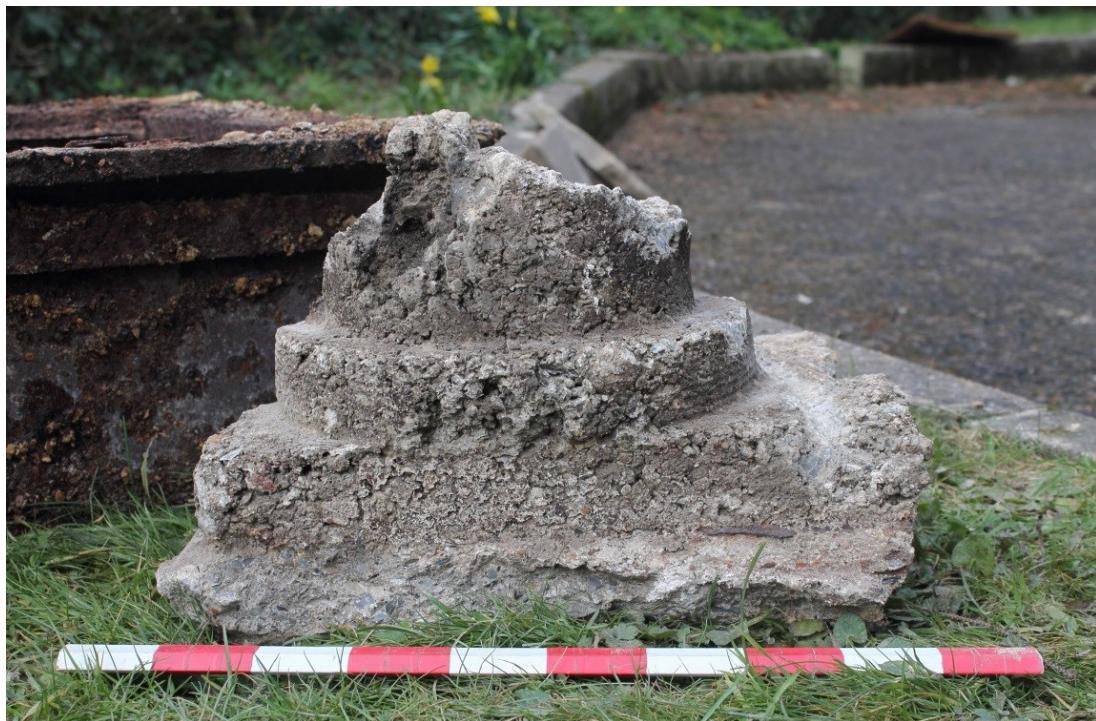
**Photo 25:** The concrete pillar-base found in the rubble under the old floor, 0.5m scale

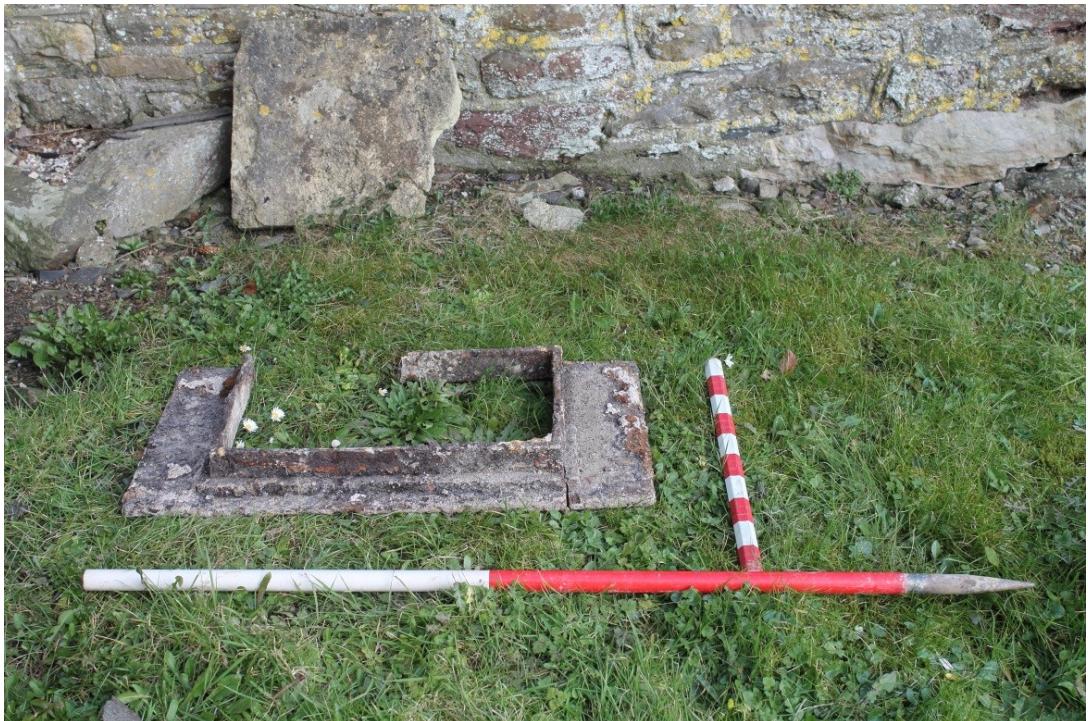
5.1.12 On the 9th of March, the stove having been removed, the rubble created by the pneumatic drill was removed from the church and the entire nave and north transept areas to be re-floored were excavated by machine under watching brief conditions to the required depth of 0.3m. More disarticulated human remains were recovered and similar small finds to previous days. A large piece of concrete resembling the base of a pillar was also recovered (Photo 25), although its actual function is not known. A square metal frame (ferrous) was also recovered which may have been a surround for an opening or for the base of an object (Photo 26).

**Photo 26:** The ferrous object resembling a surround for an opening or the base of an object, with 0.5m and 1m scale

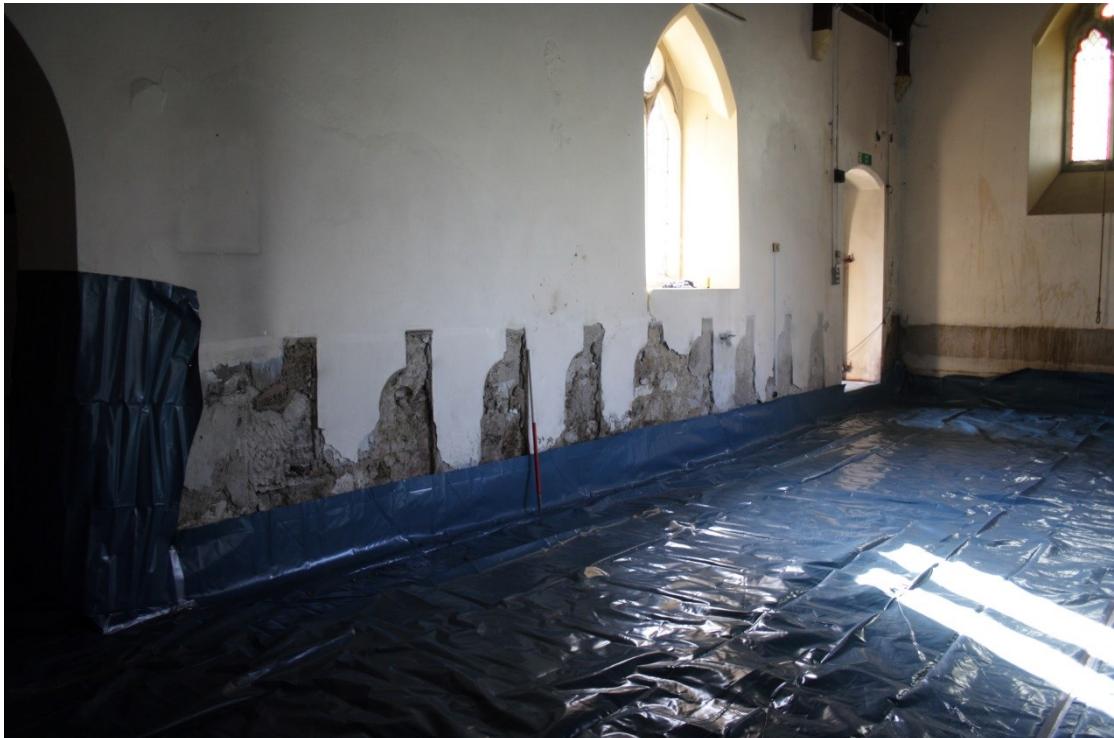
**Photo 29:** The south side of the nave after the laying down of plastic sheeting as a base for the new floor. 'Pew ghosts' line the wall, with a 1m scale.

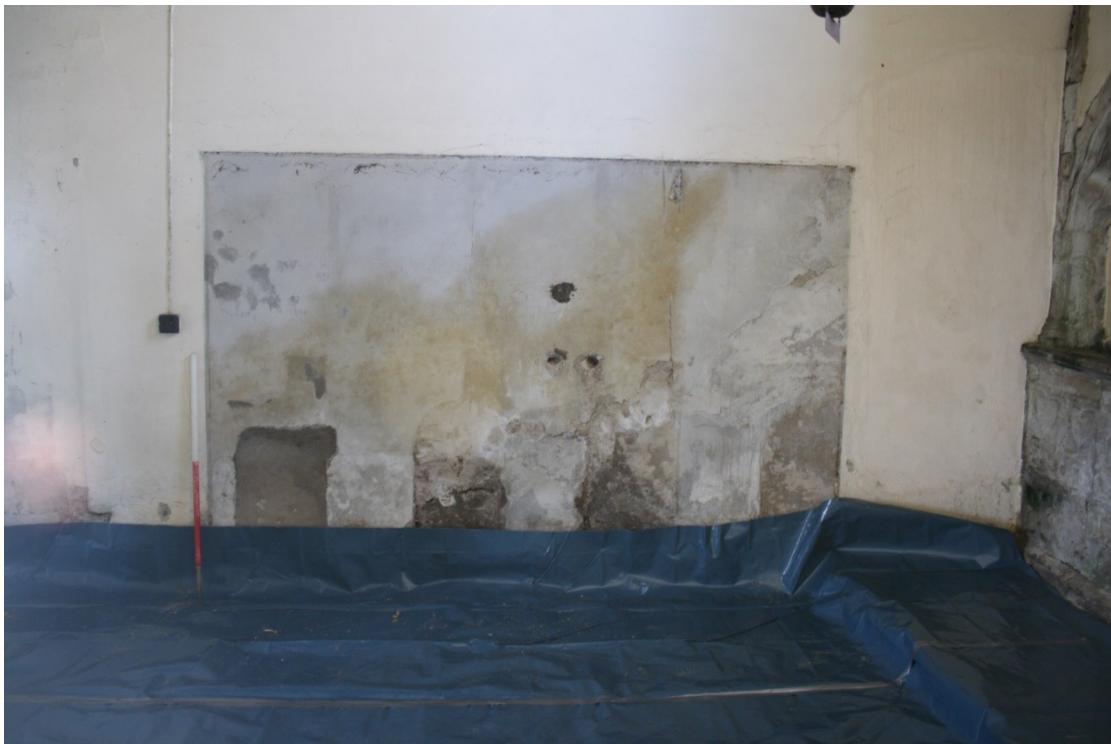
**Photo 30:** The 'pew ghosts' on the west wall of the north transept, partially covered by subsequent plastering, and surrounded by a large rectangular mark left by a cupboard that was there until recently. Plastic sheeting has been laid down as a base for the new floor. 1m scale.

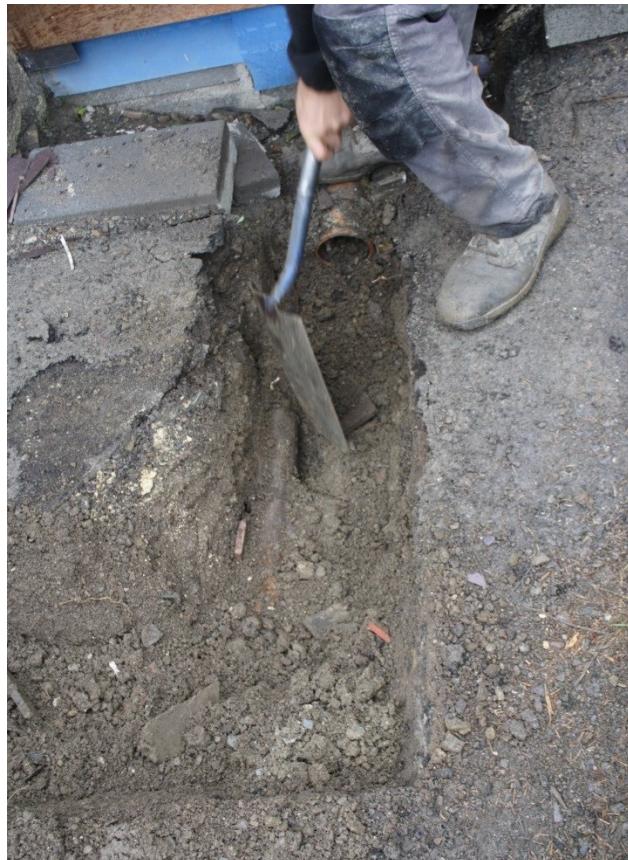
**Photo 33:** An old drainage pipe is revealed during excavation of a new drainage trench, just south of the new toilet building. The end of the new drainage pipe can also be seen, already put in place when the toilet was built.

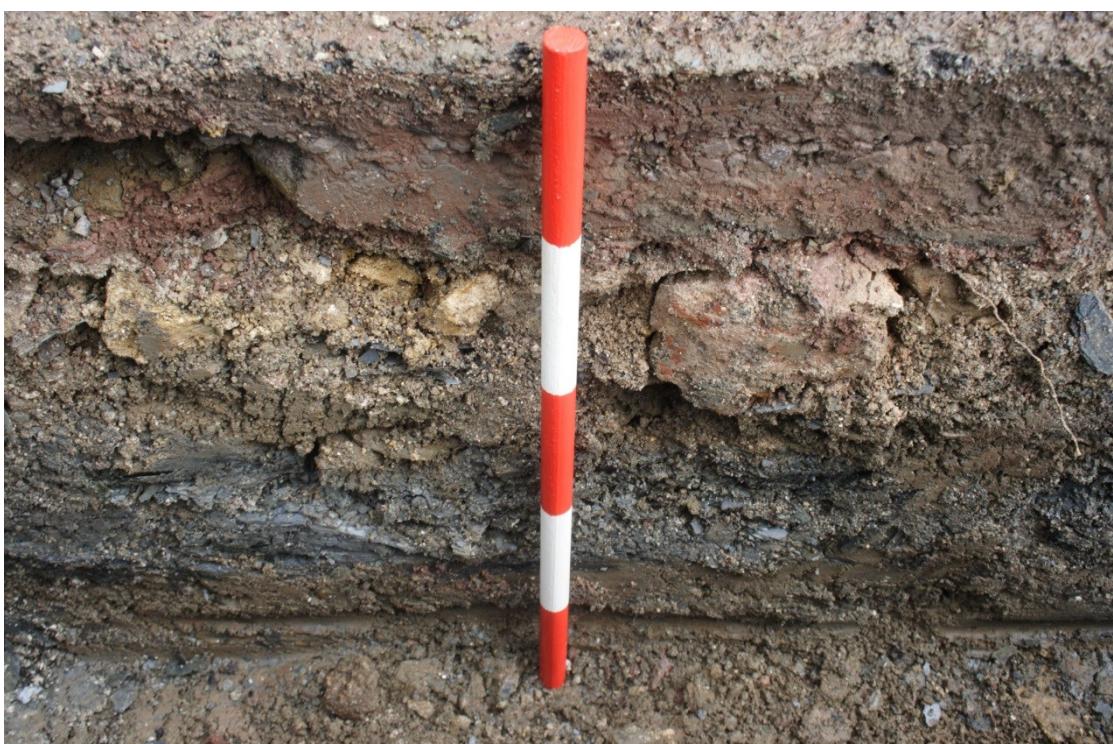
5.2.3 Underneath the tarmac path, the deposits contained no archaeological finds save for layers of building material that had presumably been laid down to build up and level the ground in preparation for the laying of the tarmac path. There were different layers of sand, soil, gravel and various types of stone (Photo 34).

**Photo 34:** Different layers of sand, soil, gravel and various types of stone were found in layers making up the ground beneath the present day tarmac path

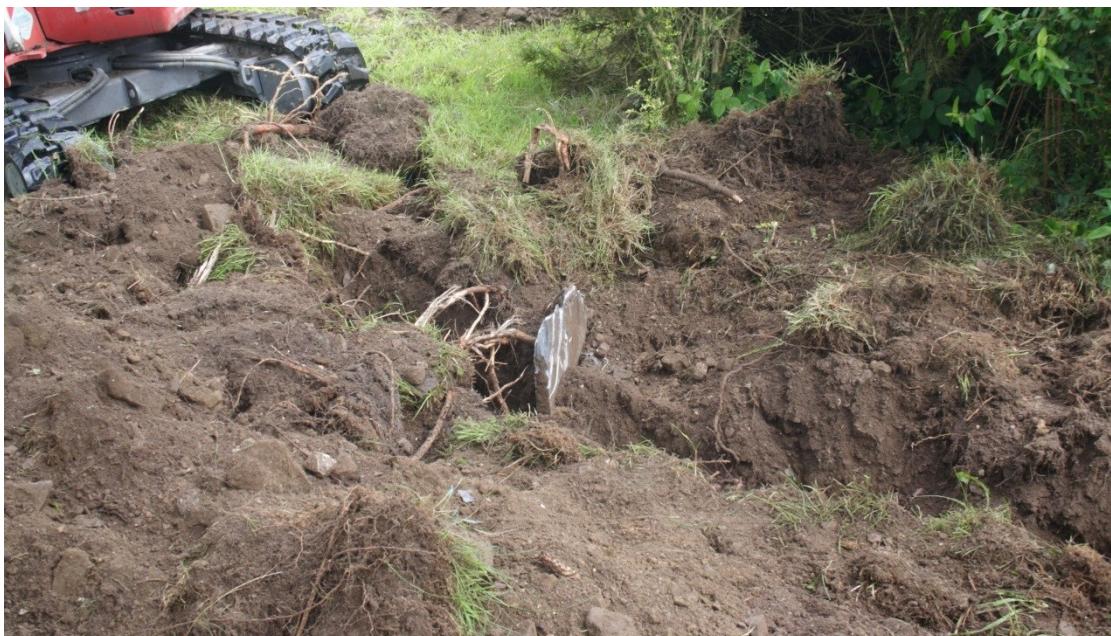
**Photo 37:** Buried headstone found in situ just below the topsoil during excavation of the new drainage trench

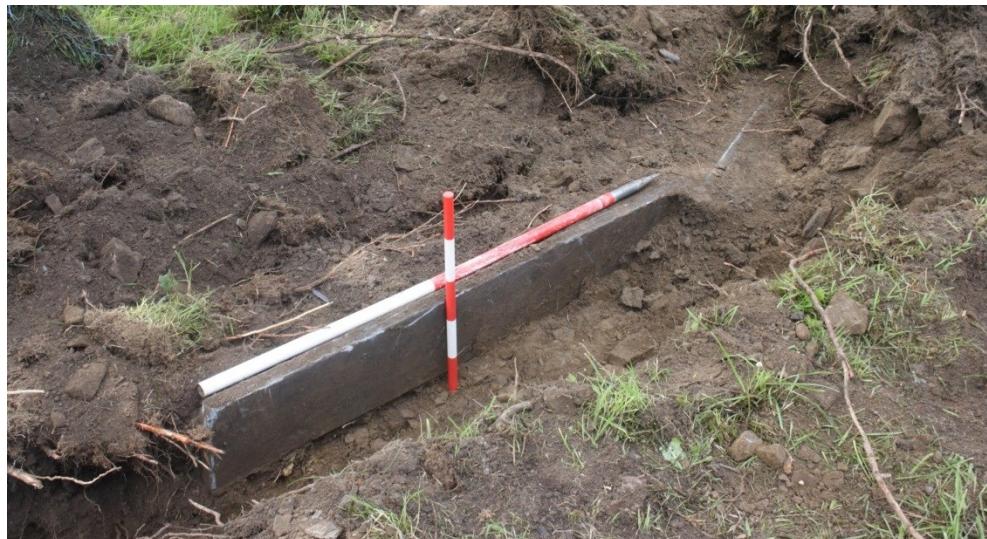
5.2.5 Photos 38 and 39 show collapsed kerbstones of a buried former pathway that were uncovered and then removed during the further excavation of the drainage trench, about 2m west of where the buried headstone had been found. Throughout this section of drainage trench dug through the grass, the only deposits encountered were topsoil and, underneath it, stone building rubble containing artefacts of post-medieval and modern date such as glass bottles, glazed china ware, clay pipe and a small aluminium container. Other occasional finds included disarticulated human bone fragments, small corroded ferrous items, oyster shells and fragments of brick, plaster and mortar.

**Photo 38:** Kerbstones of a former pathway, discovered just below the topsoil during excavation of the new drainage trench, 0.5m and 1m scales

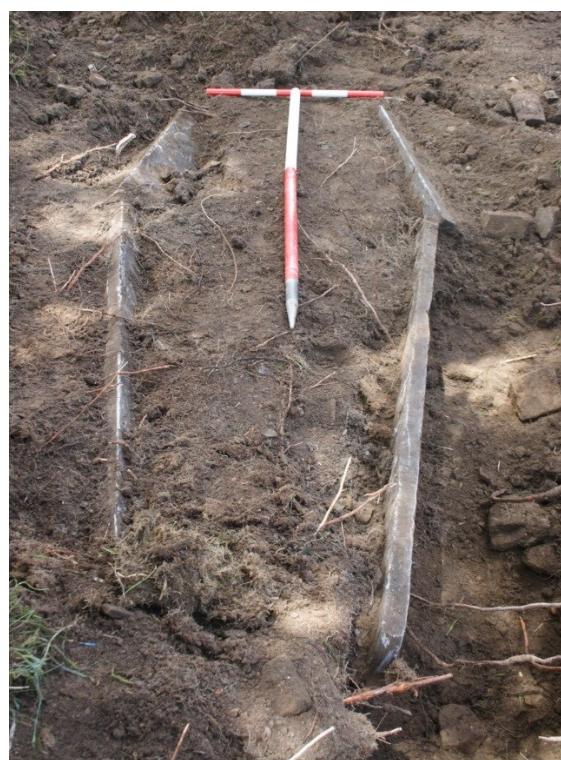
**Photo 39:** Collapsing kerbstones on either side of a former pathway, discovered just below the topsoil during excavation of the new drainage trench, 0.5m and 1m scales

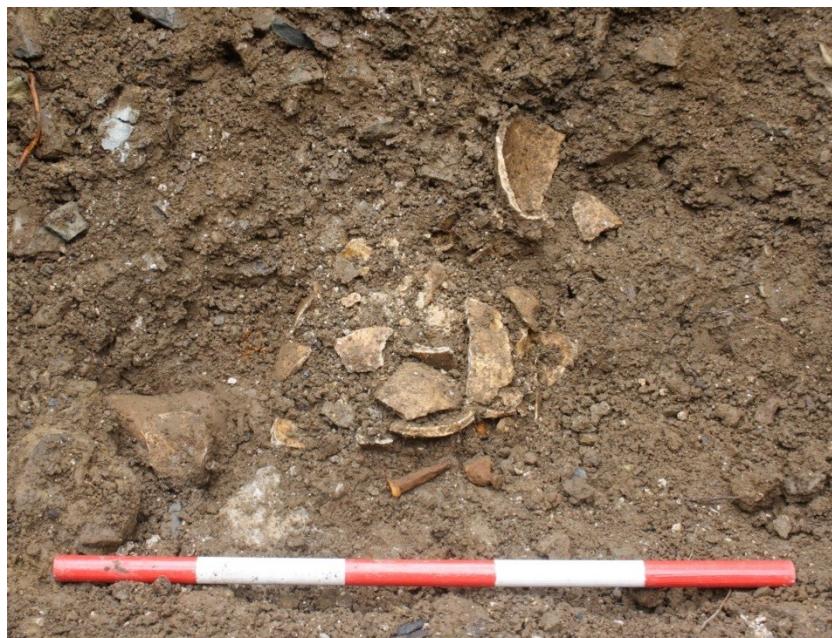
**Photo 40:** Damaged during machining, the tops of two skulls discovered at a depth of about 1m in the west-facing section of the cess pit trench, with a 0.5m scale. Corroded Iron nails can also be seen below the most prominent skull.

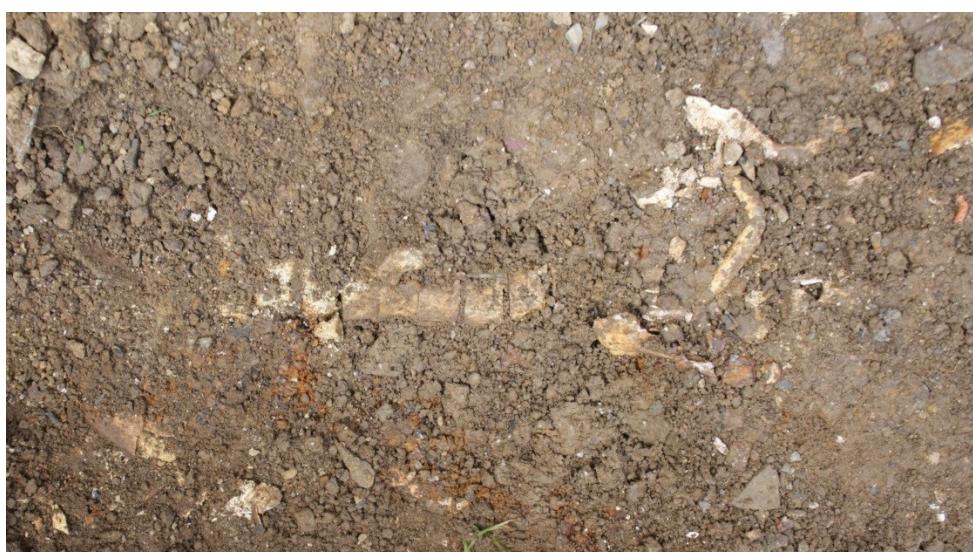
**Photo 41:** Facing south, a plan view of the burial found at the base of the cess pit trench, with the mandible and upper vertebrae most visible

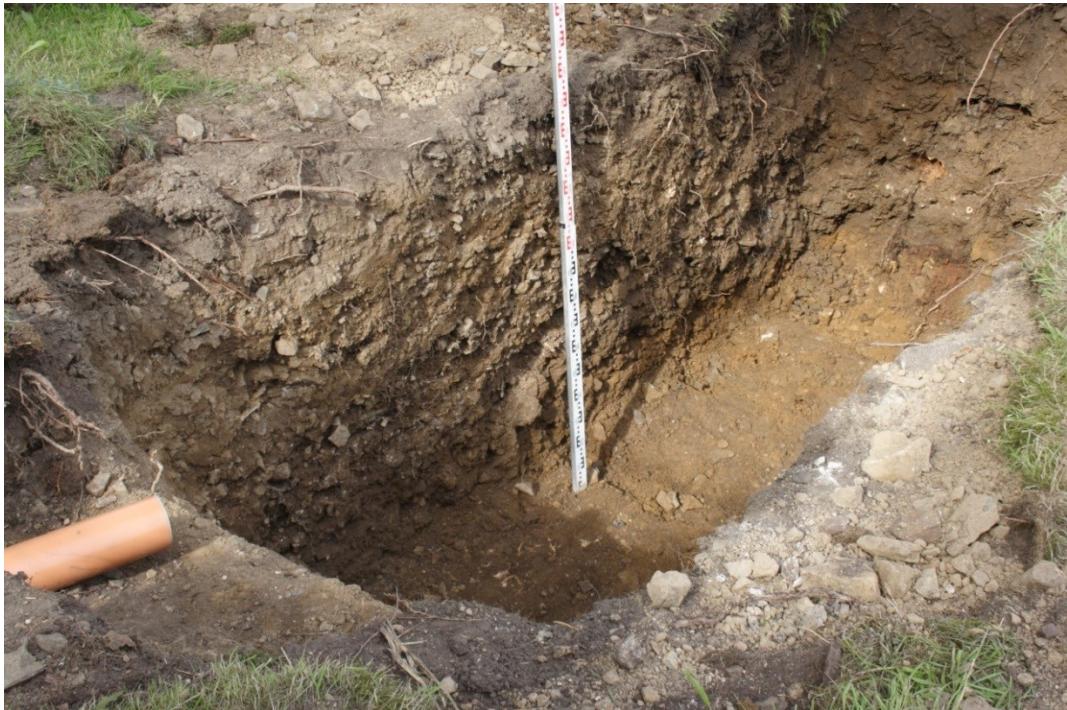
**Photo 42:** The north-facing section of the cess-pit trench, showing c.1m of buried building rubble beneath the topsoil, and then c.0.6m of buried topsoil with the subsoil showing at the bottom at the west end, with a 2m scale

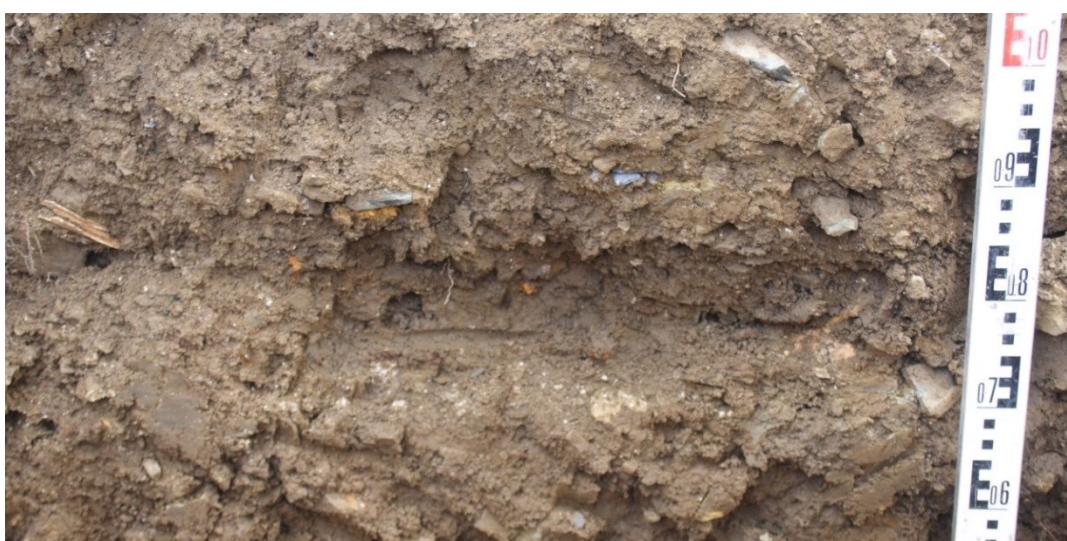
**Photo 43:** The void in the south-facing section of the pit where the right humerus of a burial was removed. Parts of other bones can be seen around the void, and the scale is in metres.
